**USING INERT GAS
TO ENHANCE
ELECTRICAL
WIRING
INSPECTION**

Electricity arcs greater distances in inert gas than in air

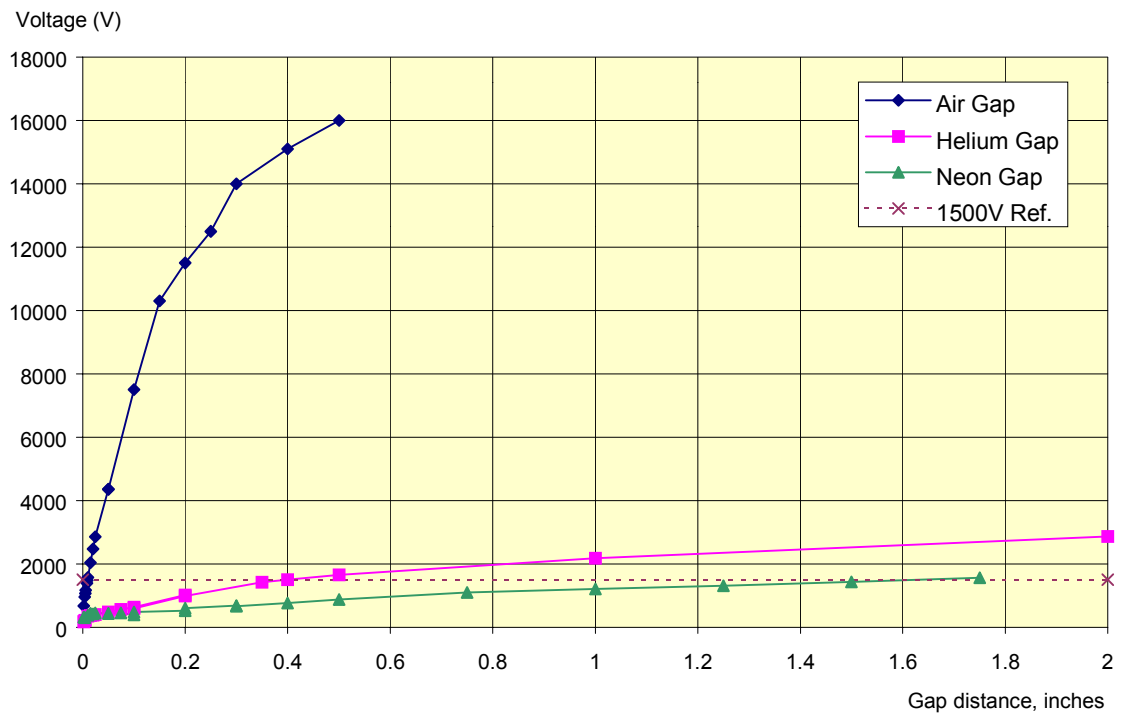
Test Voltage Required to find Insulation Defects vs. Distance Between Defects

Filling the space around wires to be tested with inert gas significantly enhances hipot testing while reducing the voltage and energy required to find insulation defects.

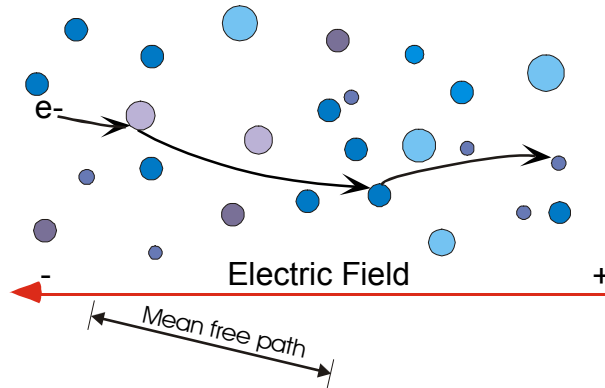
Mean free path illustrated for air. Air has a variety of atoms and molecules.

Electrons are accelerated in an electric field. In a vacuum, there is nothing for free electrons to collide with. In a gas, however, free electrons may collide with atoms or molecules (particles) in their path. The distance that an electron will travel before colliding into a particle (the electron's mean free path) depends on several factors, including the density of the gas (number of particles per unit volume) and the size of the particles.

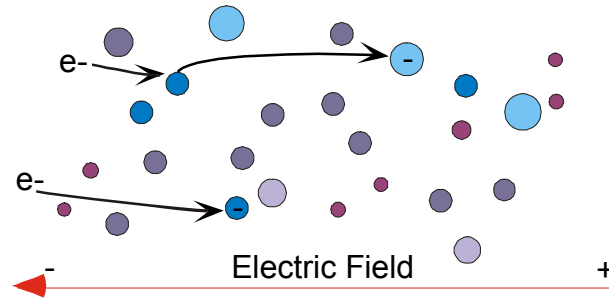
Capture of free electrons by electronegative molecules in air.

Sometimes an electron is captured when it collides with particles in its path. Electronegative gases are so called because they have electron affinity and form long-lived ions after capturing electrons. These gases are used to suppress arcs in high voltage circuit breakers. Probably the best-known arc-suppressing gas is SF_6 , which has a large electron attachment cross-section and a strong electron affinity. Gases that capture electrons include SF_6 , CF_4 , CO , CO_2 , N_2O , and other gases including many commonly found in normal air. The presence of these gases suppresses arcs by capturing free electrons. Inert gases, particularly Helium and Neon, do not capture electrons.

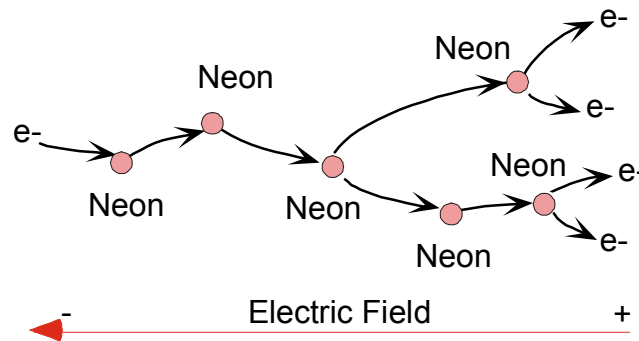
Townsend breakdown of an inert gas.

As an electron travels in an electric field, it speeds up and gains kinetic energy. If it has gained enough kinetic energy before colliding with a particle, it can cause that particle to release (emit) an electron. This can lead to a Townsend avalanche, wherein electrons hit gas molecules, producing fresh ions and electrons. If the avalanche extends from one conductor to the other, it is called an arc.

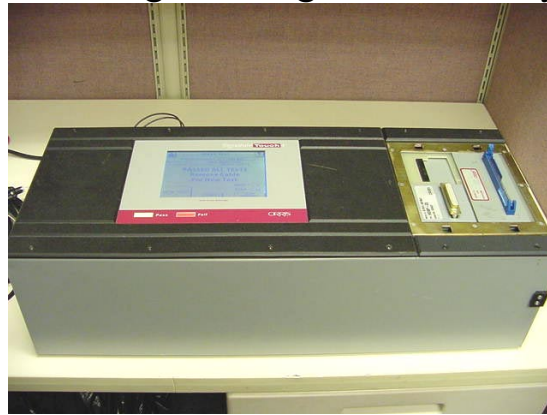
Touch 1 High-Voltage Cable Analyzer

Effectively performing the test requires the use of the Cirris Touch 1™ High-voltage analyzer in conjunction with a gas containment device.

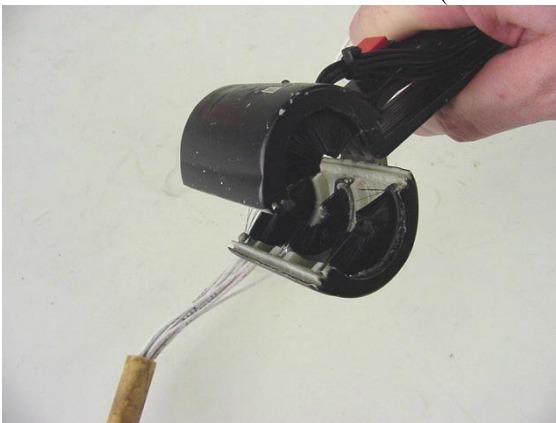
Inert Gas Wand (for smaller wire bundles)

Inert Gas Wand with three rows of brushes (inside row is conductive nylon). Provides gas containment and conductive path for low-energy arcing.

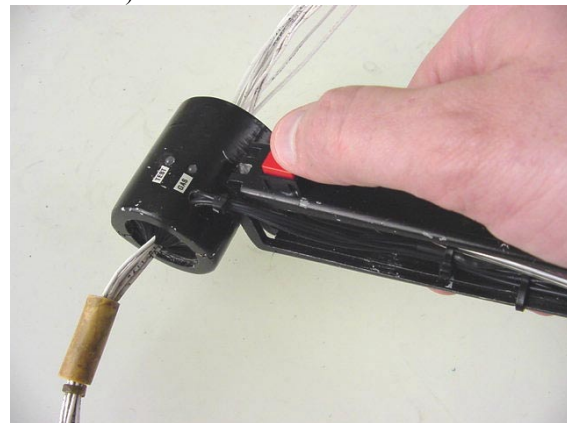
Inert Gas Wand shown clamped over the cable to be tested. Wand provides remote "Start Test" and pass/fail indicator LED's.

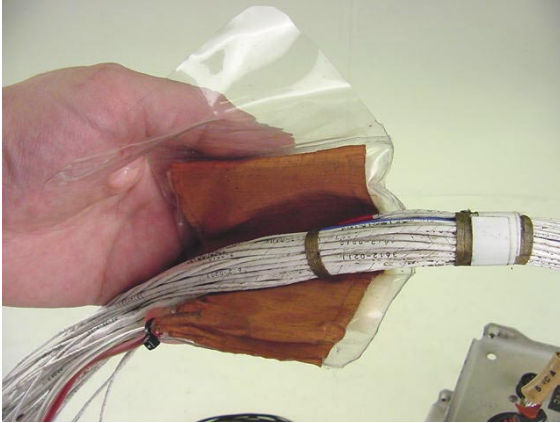
Inert Gas Cuff (for larger wire bundles)

Inert Gas Cuff positioned over a bundle of wires to be tested. Provides gas containment and conductive path for low-energy arcing.

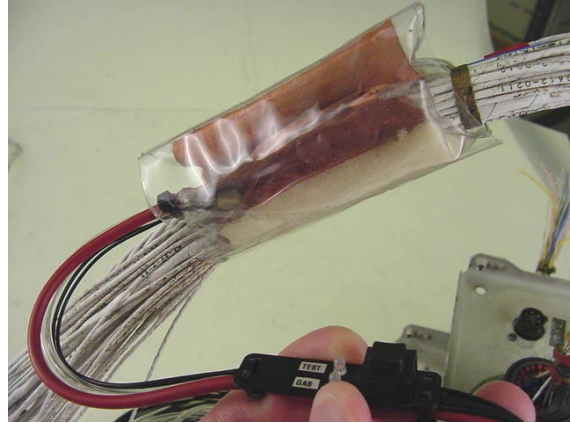
Inert Gas Cuff wrapped around wiring harness to be tested. Cuff provides remote "Start Test" and pass/fail indicator LED's.

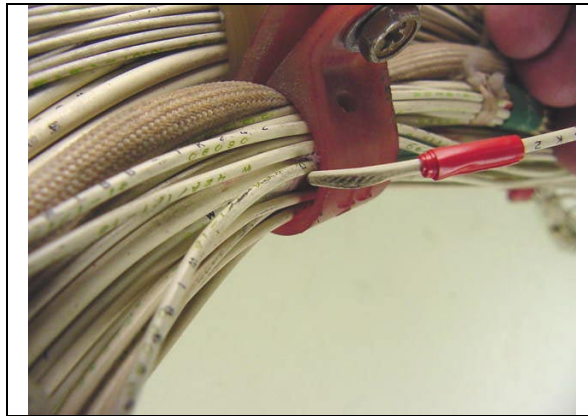
Close view of crushed insulation by a bracket. Note the diagonal lines on the wire to the left of the red tape.

There is interest in finding damaged insulation. Damage appears to have been caused during maintenance or cable extraction.

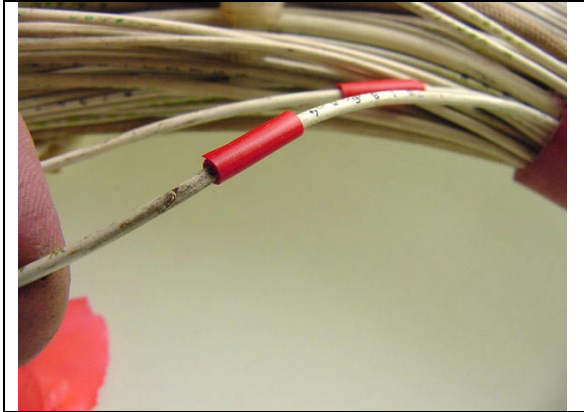
Nicked insulation by bracket. The nick can be seen to the left of the red tape.

With this sample, the insulation has been nicked, and the conductor is exposed.

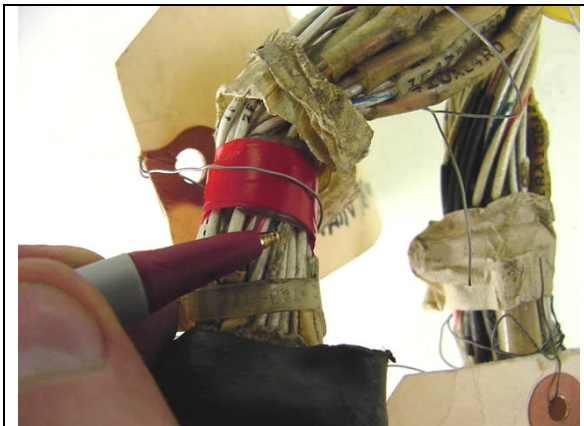
Chafed insulation at edge of label. The wire is not visibly exposed, but appears to have rubbed against something. Insulation has been compromised. The conductor IS exposed (test failed), although it can't be seen with the naked eye.

Sometimes there is damage near a wiring label due to chafing or tightening of the cable strap associated with the label.

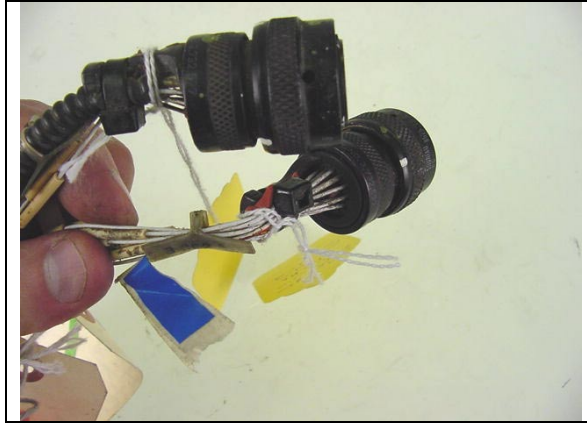
Paint rubbed off wires near backshell. The insulation is not compromised.

Here is a cable that “looks” bad, but it is intact. All tests passed, there is no damage to insulation.

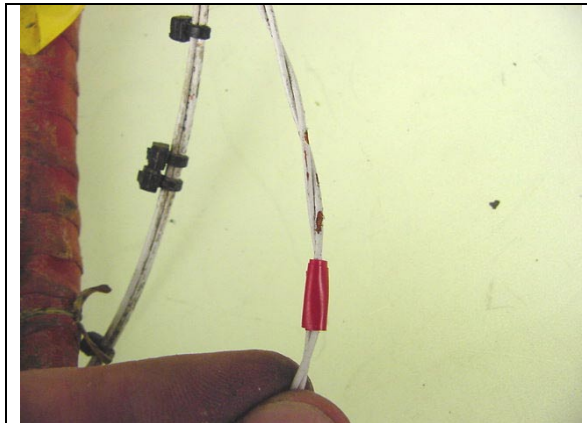
Chafed insulation. Insulation compromised.

This picture shows chafing damage, probably caused by a cable clamp rubbing the wires in question.

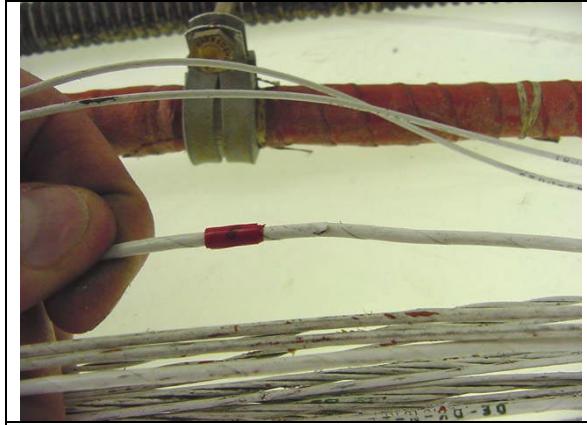
Nicked insulation. Insulation compromised.

Sometimes the damage can't be seen easily. This insulation has been nicked, as can be seen to the right of the red marking tape.

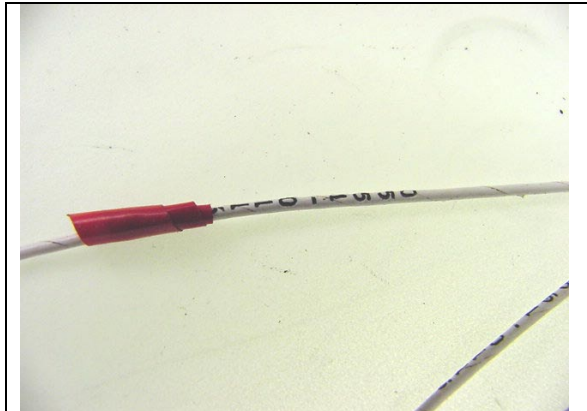
Wire marking 0551-0116 perforates insulation (multiple characters) in eight separate character groups along wire harness sample. The insulation is compromised on the following underlined characters: 0551-0116.

This is an excellent example of wire marking being the cause of damaged insulation. (Note: after a failed hipot test on this wire, a static discharge gun was used to pinpoint exactly which characters had compromised the insulation)

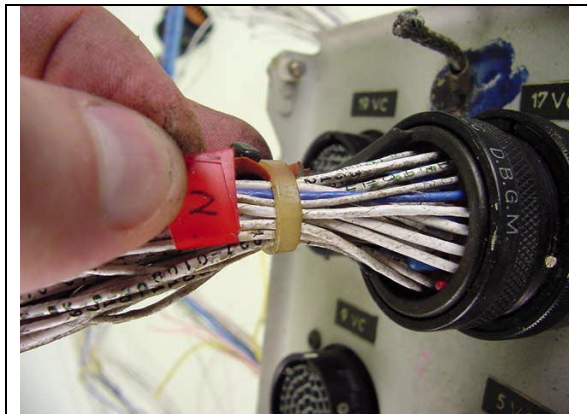
“1” wire mark perforates insulation, midway between red tape and cable clamp.

This is another excellent example of wire marking being the cause of damaged insulation. Only the character “1” perforates the insulation. The insulation is damaged by this character in several places along the length of the wire sample.

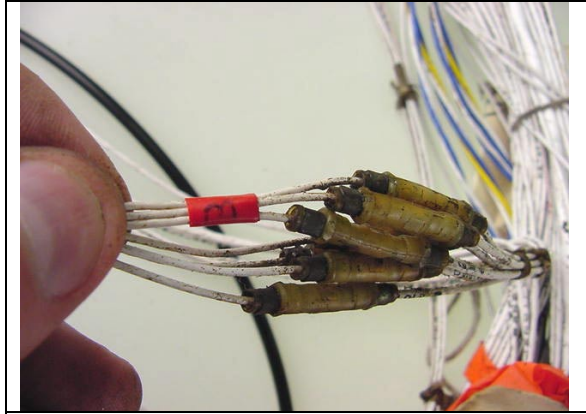
Non-environmental seal on 3 crimps (splices).

Sometimes wire repair leaves the wire harness vulnerable. In this sample, three of the wire crimps do not have an environmental seal, allowing contaminants to work their way to the conductor.

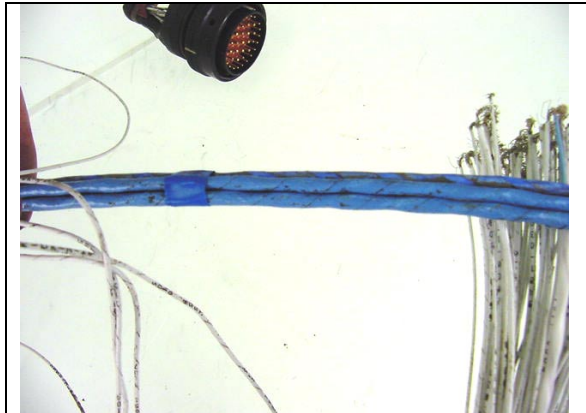
Blue shield wrap (insulating tape) does not provide an environmental seal.

Most types of wrapped insulation do not provide a good environmental seal. Although the test failed, it is probably not critical because the exposed conductor is a shield.

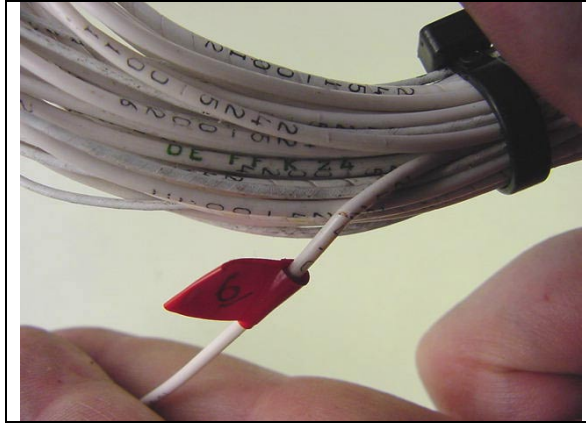
A crack or nick was found between the “2” and “4” printed on this wire. As with much of the damage found during these tests, this crack was first identified while still buried in the bundle of wires.

Sometimes insulation damage is not on the outermost wires in the bundle. In this example, the damaged wire is covered by two layers of wire in the bundle. None of the other wires in the bundle were damaged.
